**US Army Corps
of Engineers**

Construction Engineering
Research Laboratory

CERL Technical Report 99/47
June 1999

Geophysical and Archaeological Investigations of Historic Sites at Fort Riley, Kansas

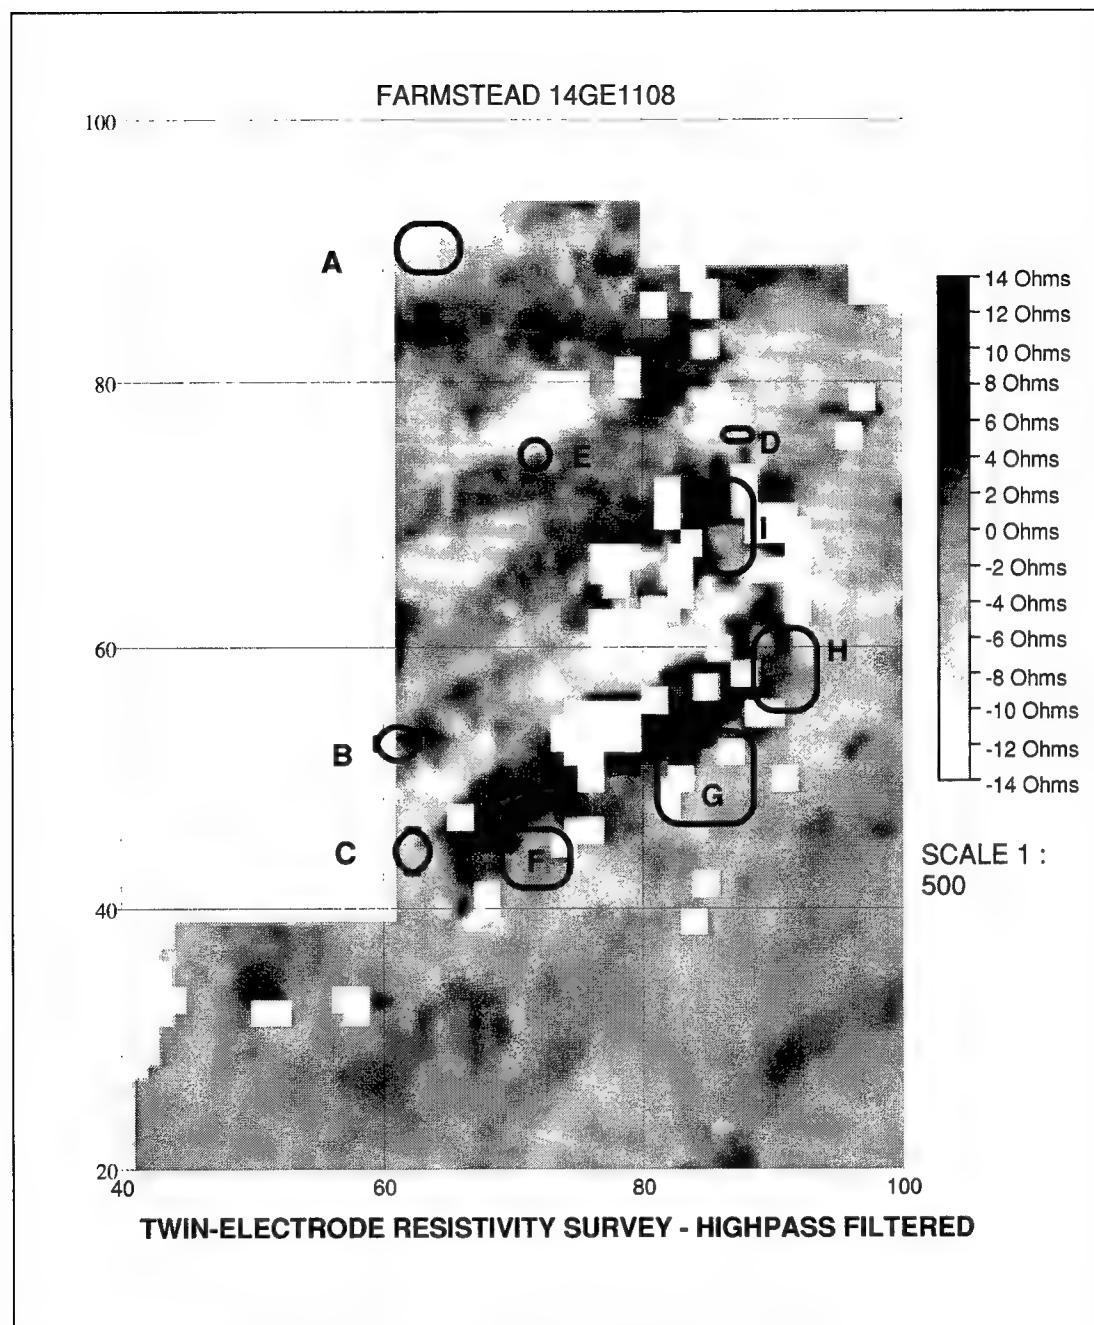
Figure 2. Resistivity map of Farmstead Site 14GE1108 (Somers 1998).

High-resistivity features F, G, H, and I appear to be reasonably well preserved (Figure 2). When examined in detail, each has very localized clusters of high resistivity. If anything in the 14GE1108 resistivity data is indicative of subsurface stone, cement, or rubble-fill features with structural integrity, it is F, G, H, and I. If found to be associated with cultural material on the surface, these features should be tested.

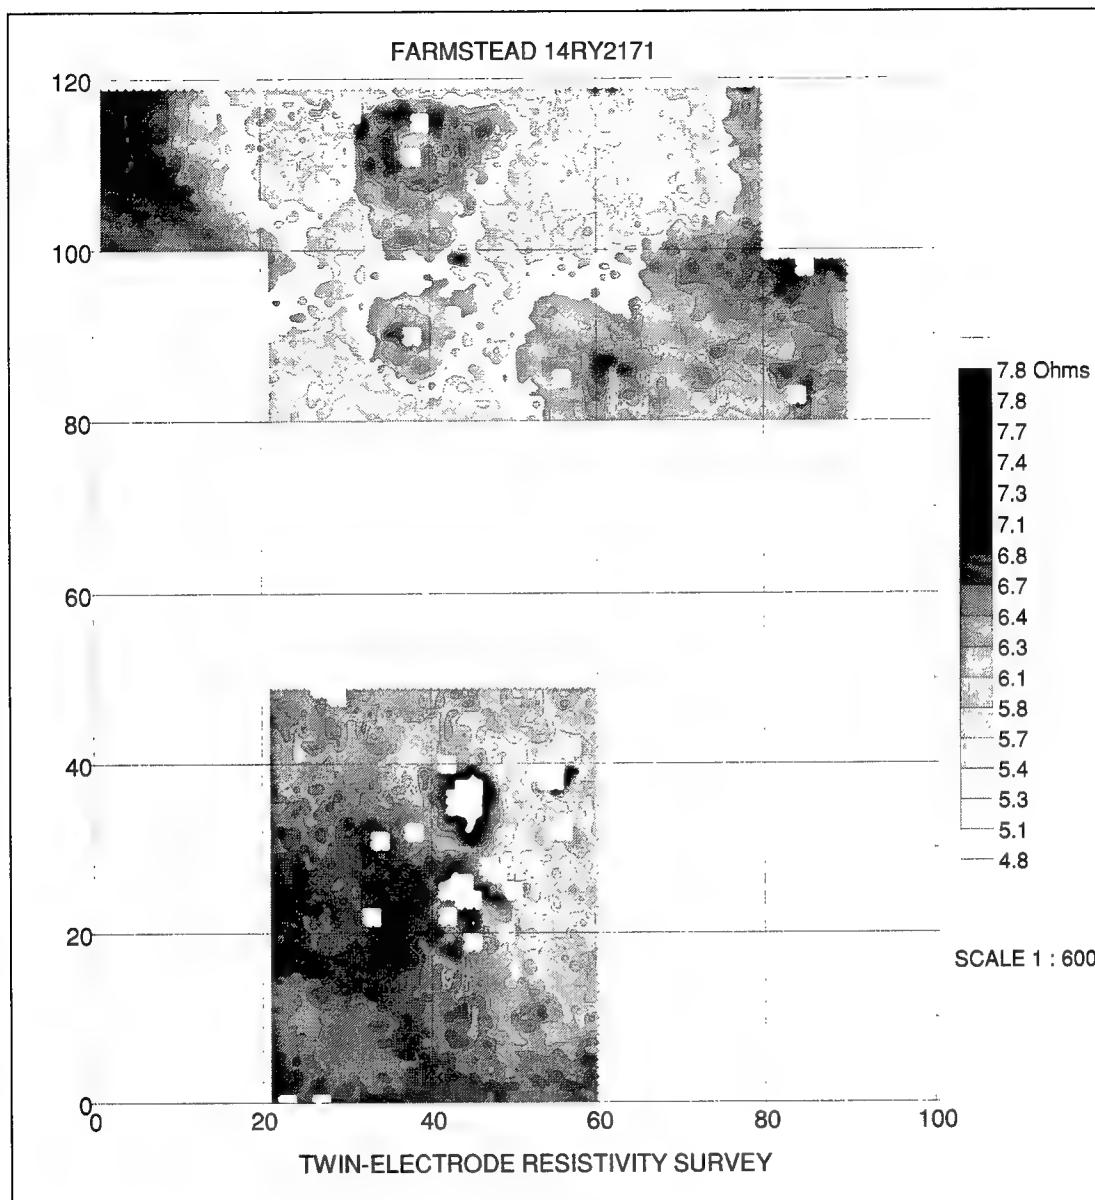
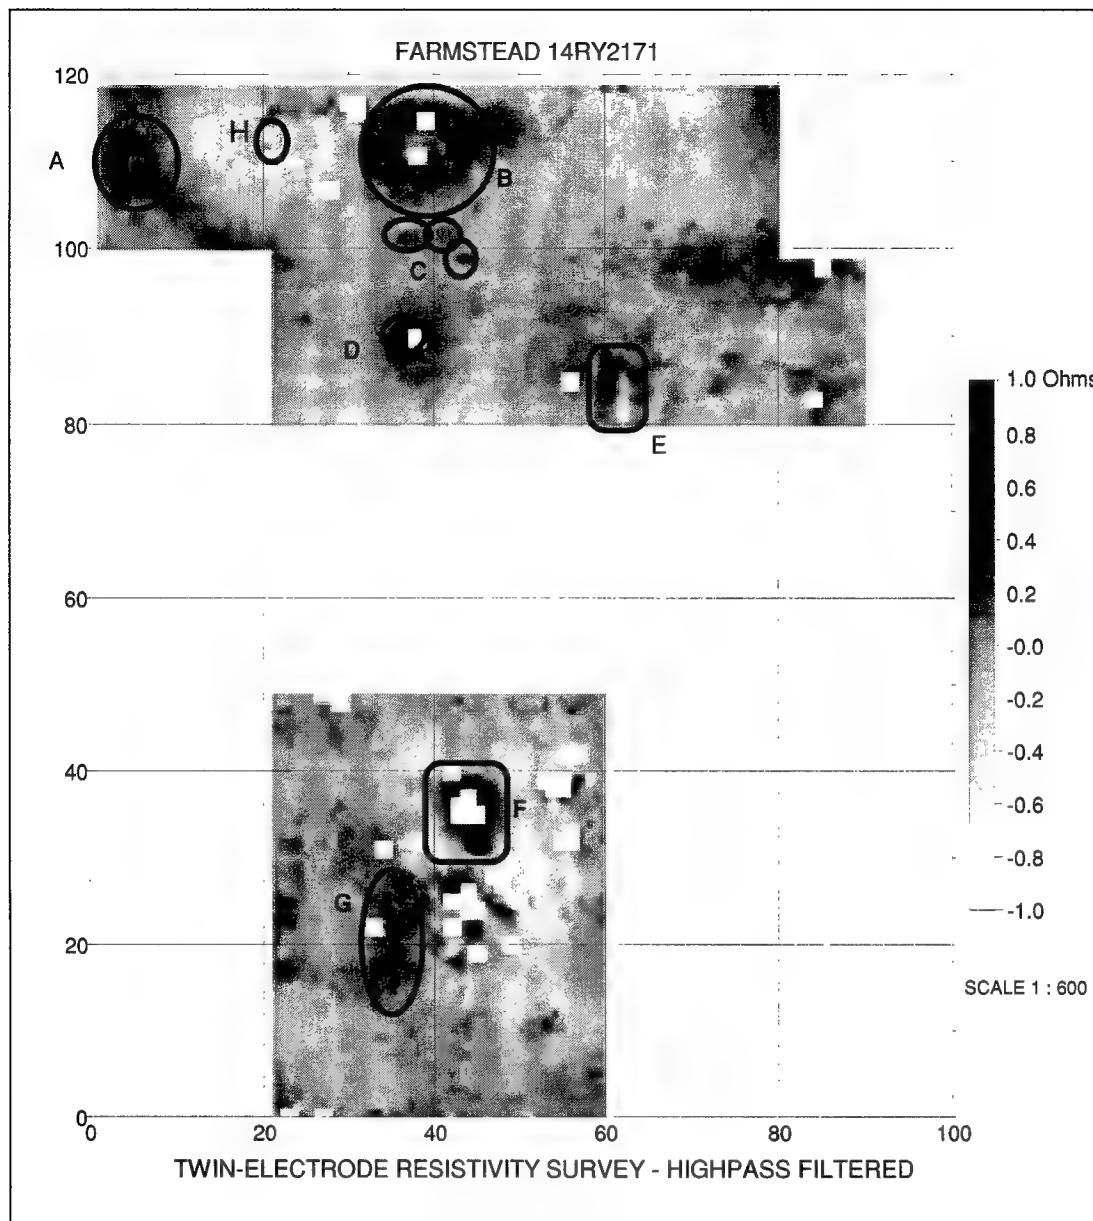
Figure 12. Resistivity contour map of Farmstead 14RY2171 (Somers 1998).

The survey maps from 14RY2171 are dominated by high-resistivity features (Figures 12 and 13, Tables 13–15). Most of these features are in the immediate vicinity of a surface depression and building foundation, both of which can be seen on the site surface. Features C and G have no surface expression. The three features jointly designated as C are very localized and are probably individual stones or cement pieces. Feature G is a rectangular, dense cluster located west of a building foundation. This feature could be building debris from site destruction or remnants of some unknown activity area.

Feature E consists of a well-defined, high-resistivity cluster that contains a very low-resistivity interior. The low-resistivity interior feature is probably associated with moist clay soils or perhaps a north-south oriented metal pipe. Feature E may represent a water resource.

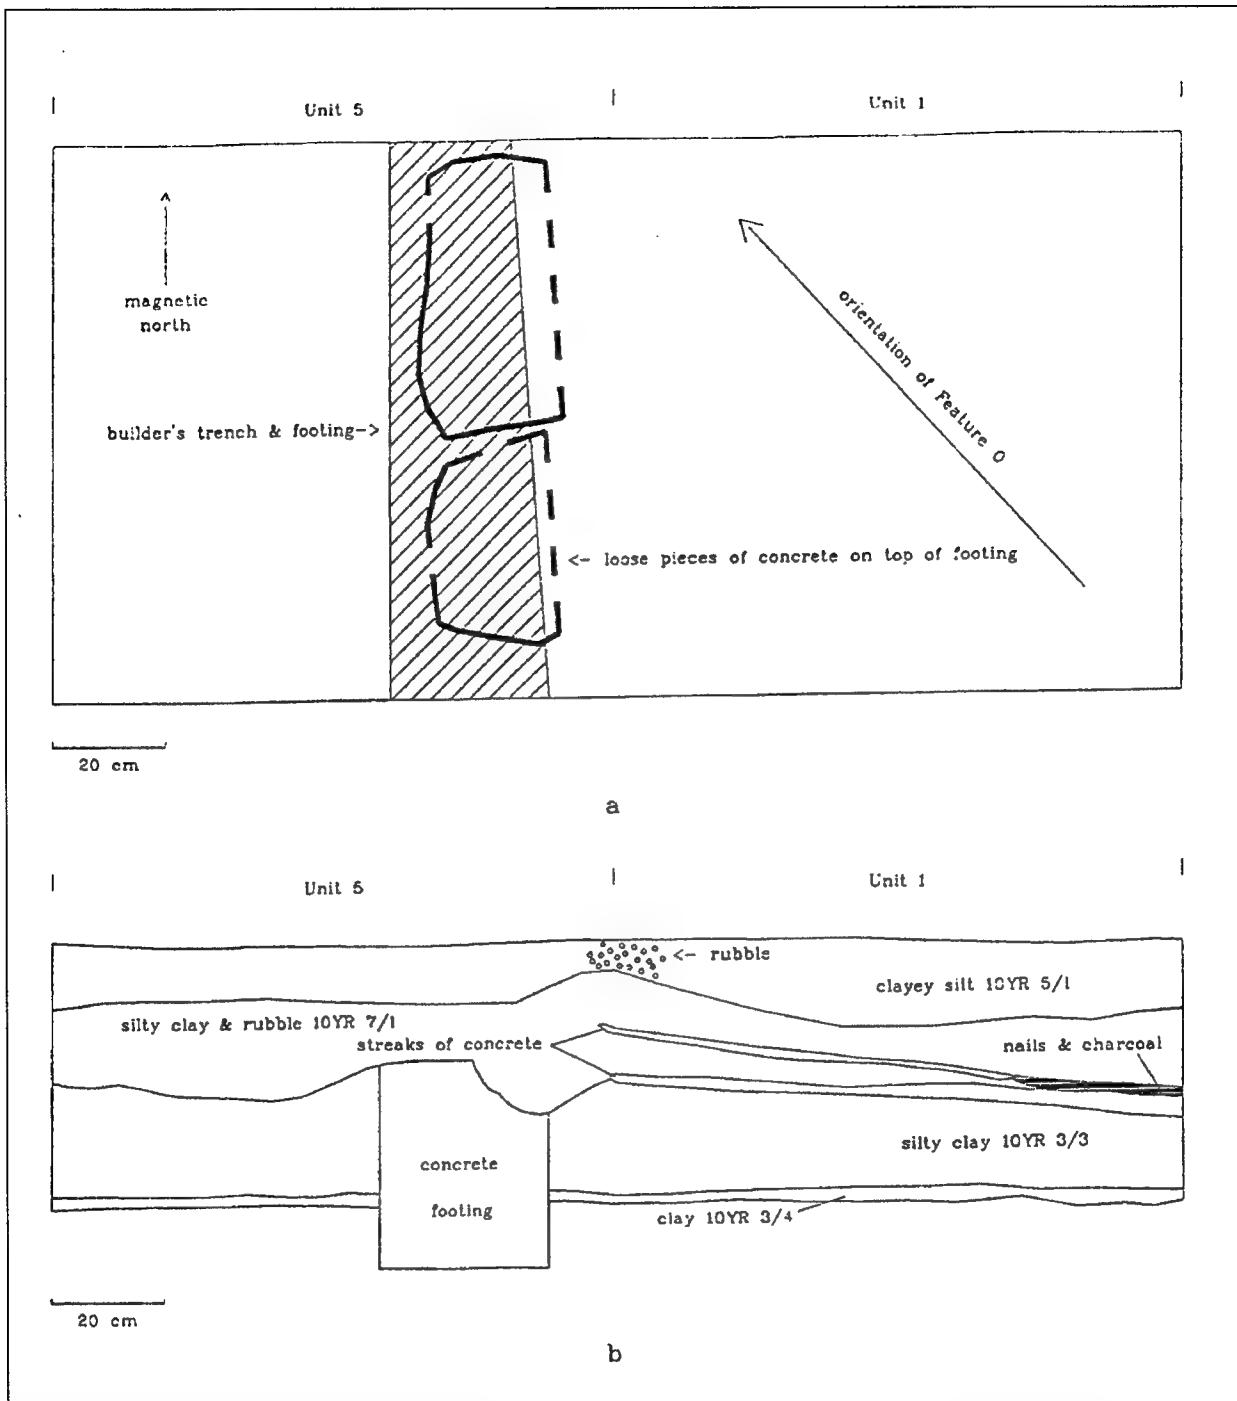
Figure 30. Floor plan (a) and mirror image (viewed from the south) profile (b) of the south wall of Test Units 1 and 5 (Larson and Penny 1998).

foundation wall. These same items can be seen in the floor plan and wall profile presented in Figure 30.
